Case Study

U-Packing with a PTFE Jacket

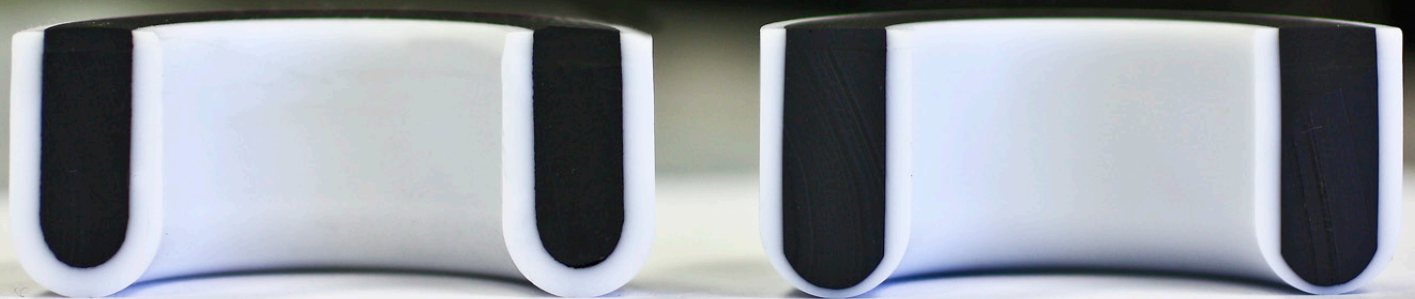
The picture below shows the same product, U-packing with a PTFE jacket, from two different suppliers. The U-packing on the left is from Hi-Tech Seals and has a uniformed PTFE jacket. The U-packing on the right is from an alternative supplier. The thickness of this part's PTFE jacket is inconsistent.

Hi-Tech Seals' U-packing had been used by a customer for a number of years with great success. The customer received the U-packing on the right after they sought out a lower priced alternative. Upon inspecting the alternative U-packing, it was concluded that the thickness of the PTFE jacket was inconsistent. This caused enough concern that the alternate product was returned without being implemented in the application. The customer has decided to continue using Hi-Tech Seals U-packing as it is a good quality part and offers reliable performance.
